CRACK PROPAGATION IN ELECTRON BEAM WELDED Ti-6Al-4V

UNDER SPECTRUM LOADING CONDITIONS

C. E. Neu
Aircraft and Crew Systems Technology Directorate
NAVAL AIR DEVELOPMENT CENTER
Warminster, Pennsylvania 18974

18 December 1980

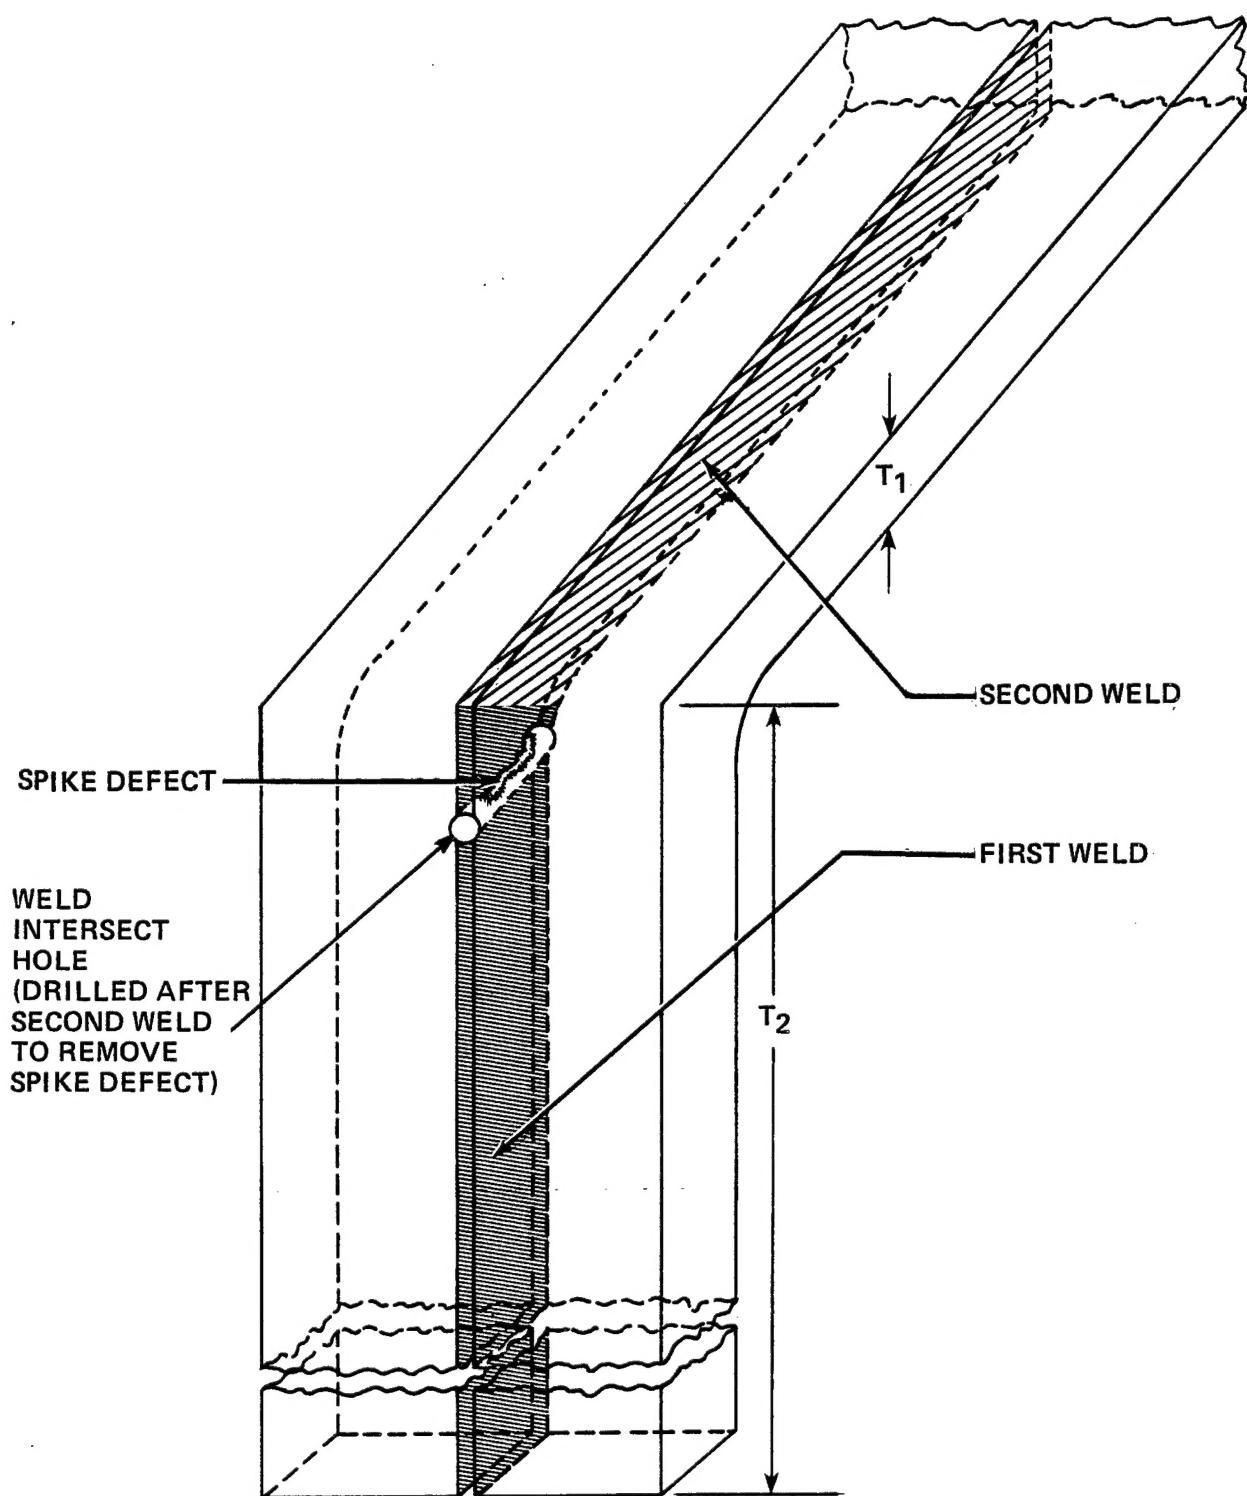
Figure 1. Spike Defects and Weld Intersect Holes

This test program was undertaken as a result of the premature failure of an F-14A aircraft wing carrythrough section test article. The failure occurred by fatigue crack propagation originating at a "spike" defect at a weld intersection point. As shown schematically in Figure 1, a "spike" defect occurs unavoidably when two electron beam welds intersect. After the first weld is completed, the second weld is made with parameters set for thickness T_1 . When the electron beam encounters the preexisting weld, it "sees" an effective thickness of T_2 , the entire length of the first weld. A defect occurs at the limit of penetration of the beam. Standard procedure in fabrication of the wing carrythrough section is to remove the defect with a drilled hole. In the case of the fatigue test article, an incompletely removed defect at the surface of the hole escaped detection and served as the failure origin.

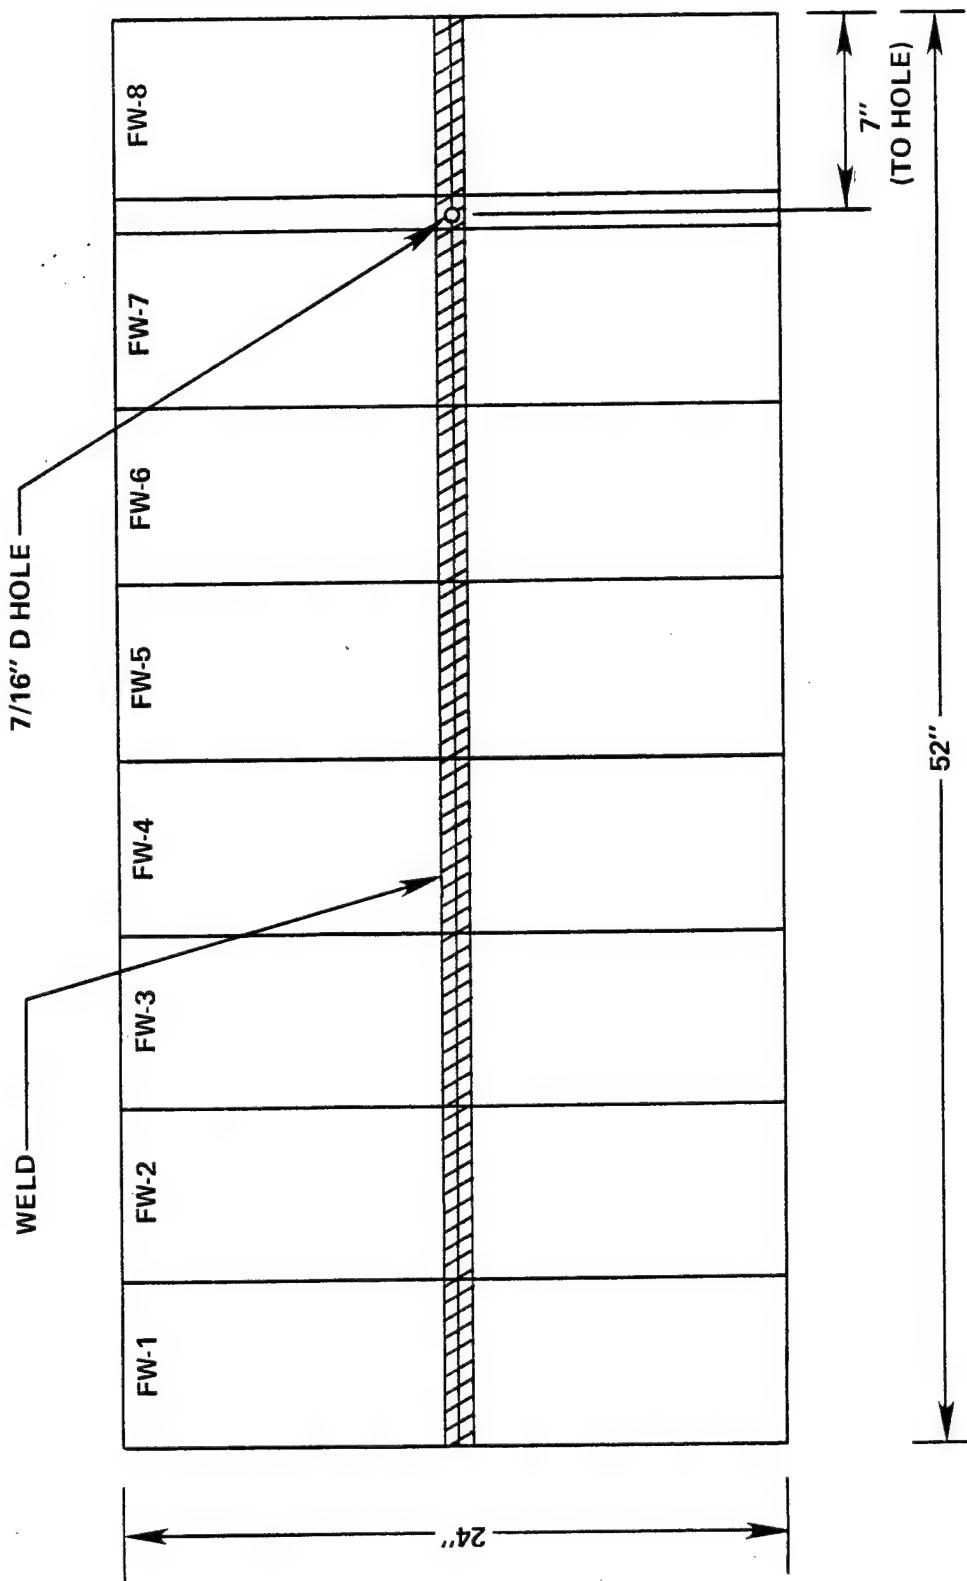
Figure 2. Titanium Electron Beam Weld Specimen Layout Diagram

Figure 2 shows the test specimen layout for the welded panel. The hole where the above mentioned burst defect was removed is indicated on the figure near the finish end of the weld.

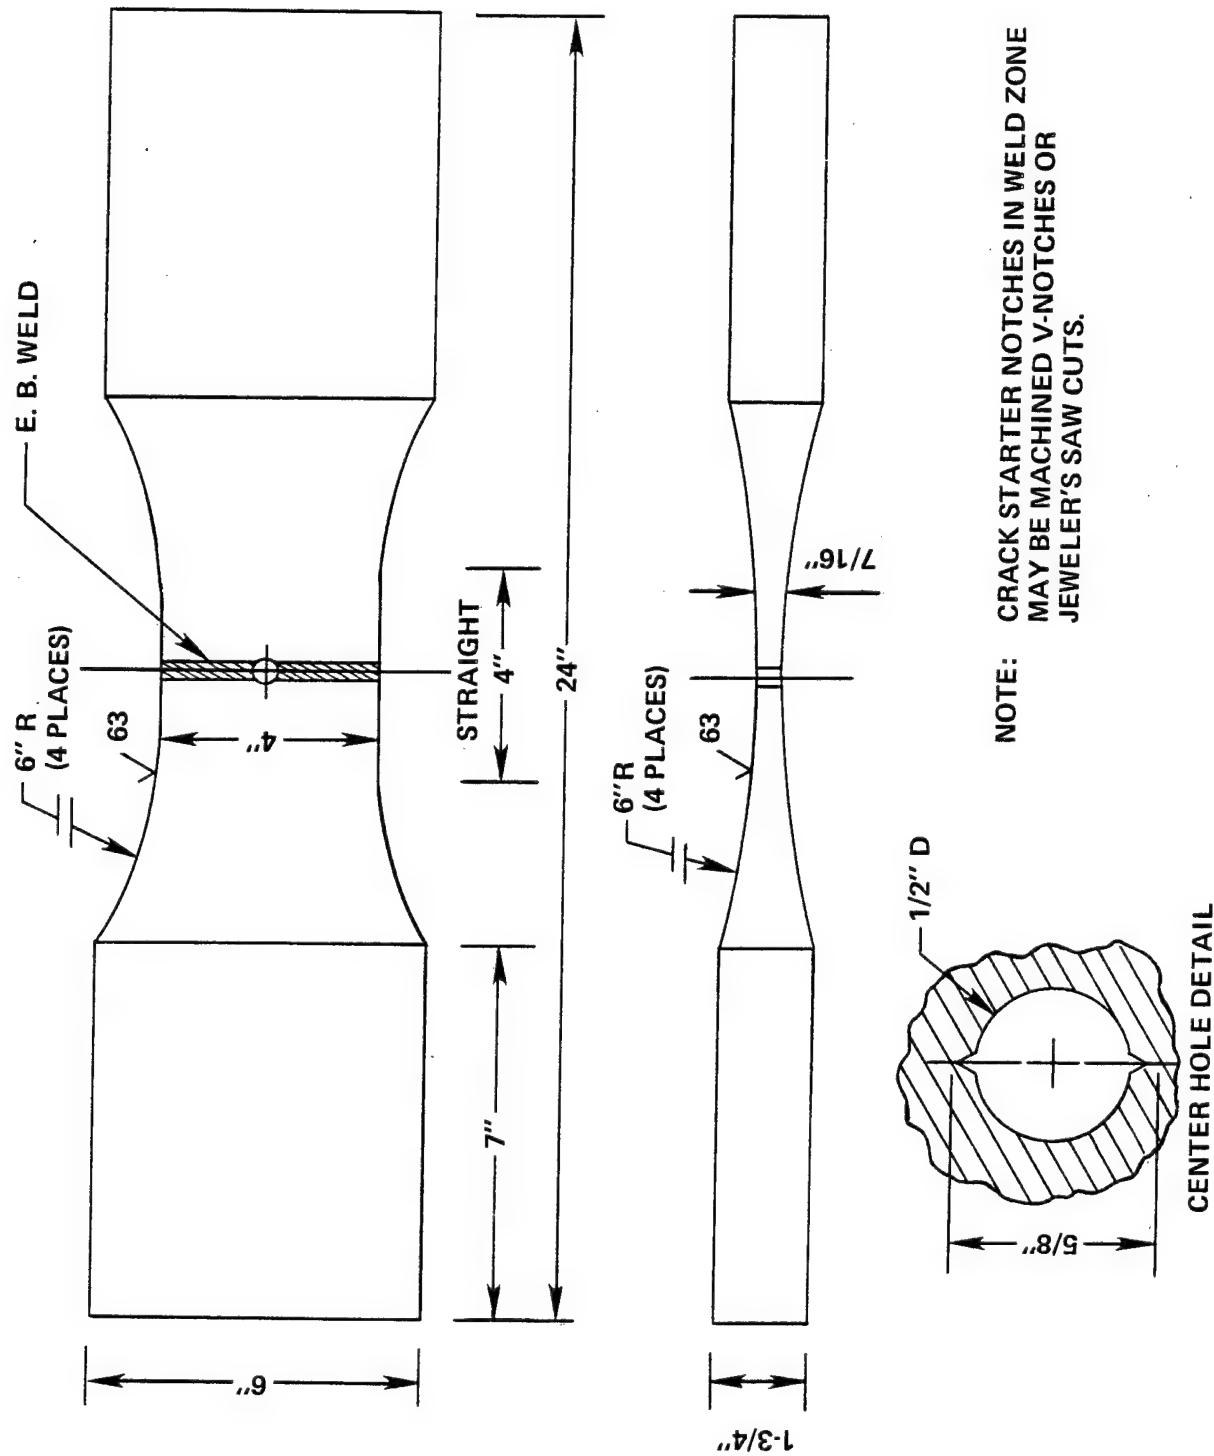
Figure 3. Titanium Flawed Electron Beam Weld Fatigue Specimen

The specimen configuration used (Figure 3) was a center notched panel with grip ends designed for clamping rather than the more common pin loading arrangement. Clamped ends were required in order to prevent rotation of the specimen under compressive loads and to avoid pin-slamming during transition between tension and compression.

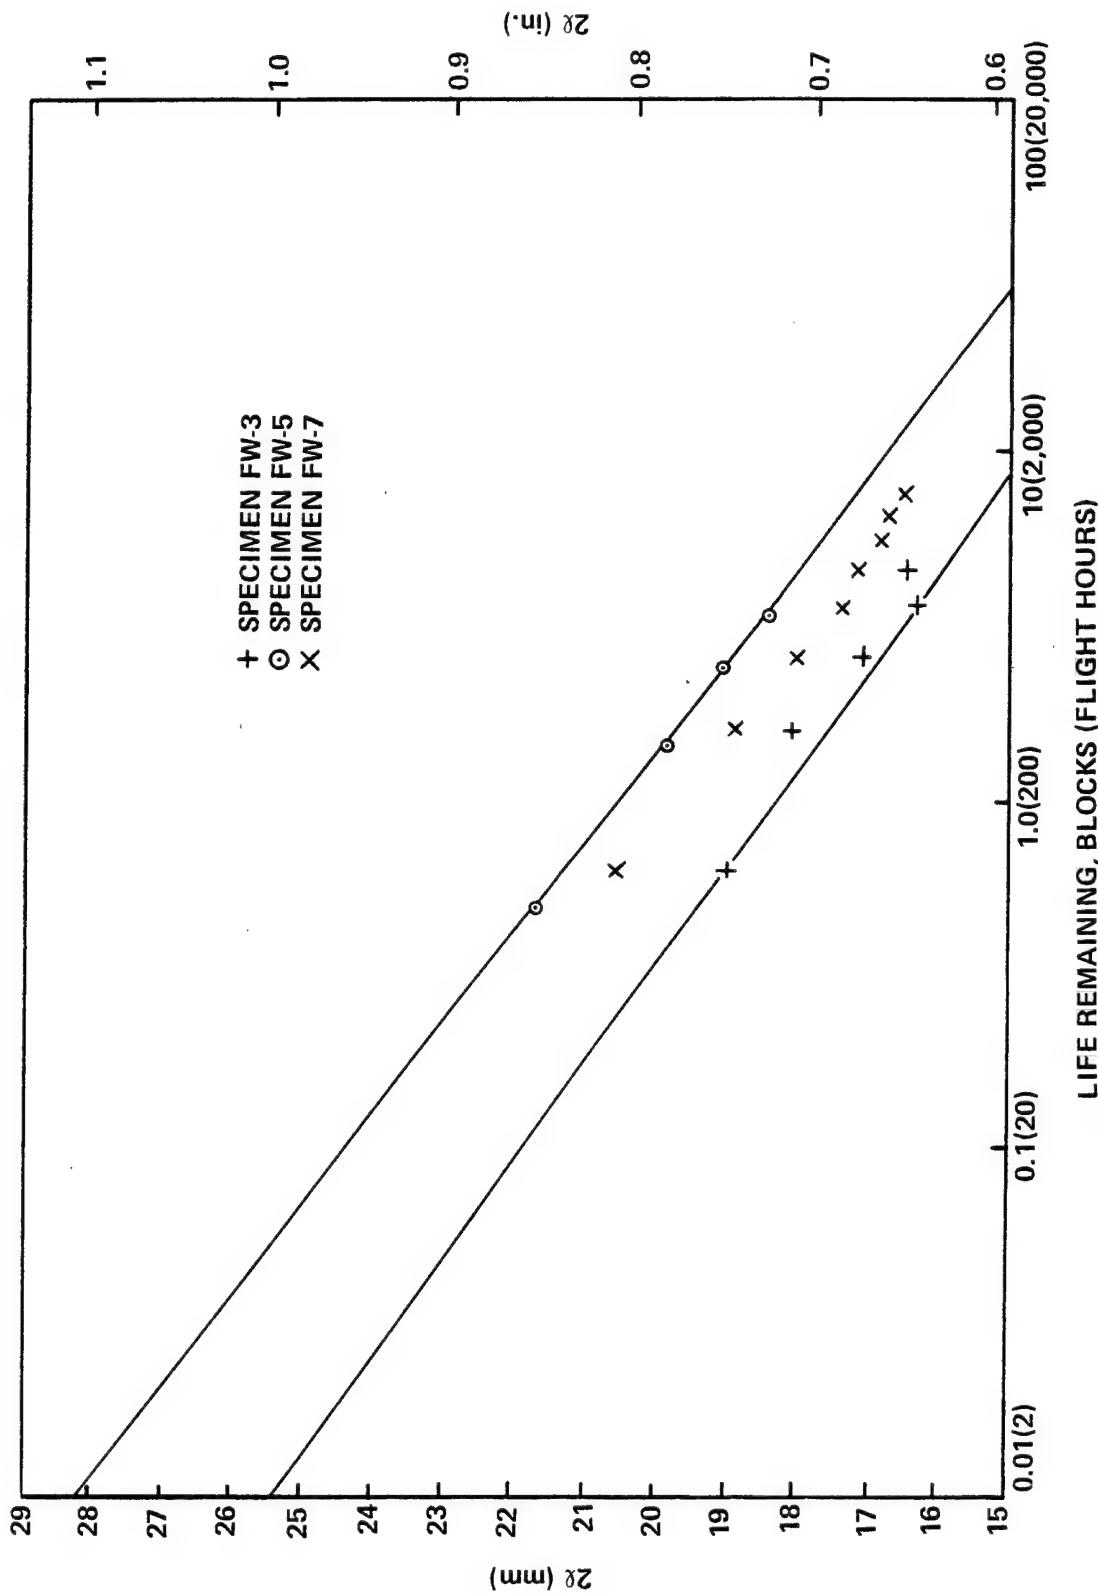
Figure 5. Total Crack Length vs. Fatigue Life Expectancy for Center Cracked Specimens under 4G Spectrum Loading

Several analytical operations were performed to convert the data into a form useful for predicting weld defect fatigue behavior in F-14 aircraft. The elapsed flight hours corresponding to each crack length measurement were converted to flight hours remaining before failure, or life expectancies. The total crack lengths ($2 l$) were then plotted against the logarithms of the life expectancies so that the range of data points could be reasonably bounded by straight lines. The crack length vs. life expectancy curves are hyperbola-like and not amenable to graphical interpretation with linear coordinates. These plots are shown in Figures 5 and 6. From bounds of the data, ranges of life expectancies for any crack length could be inferred.

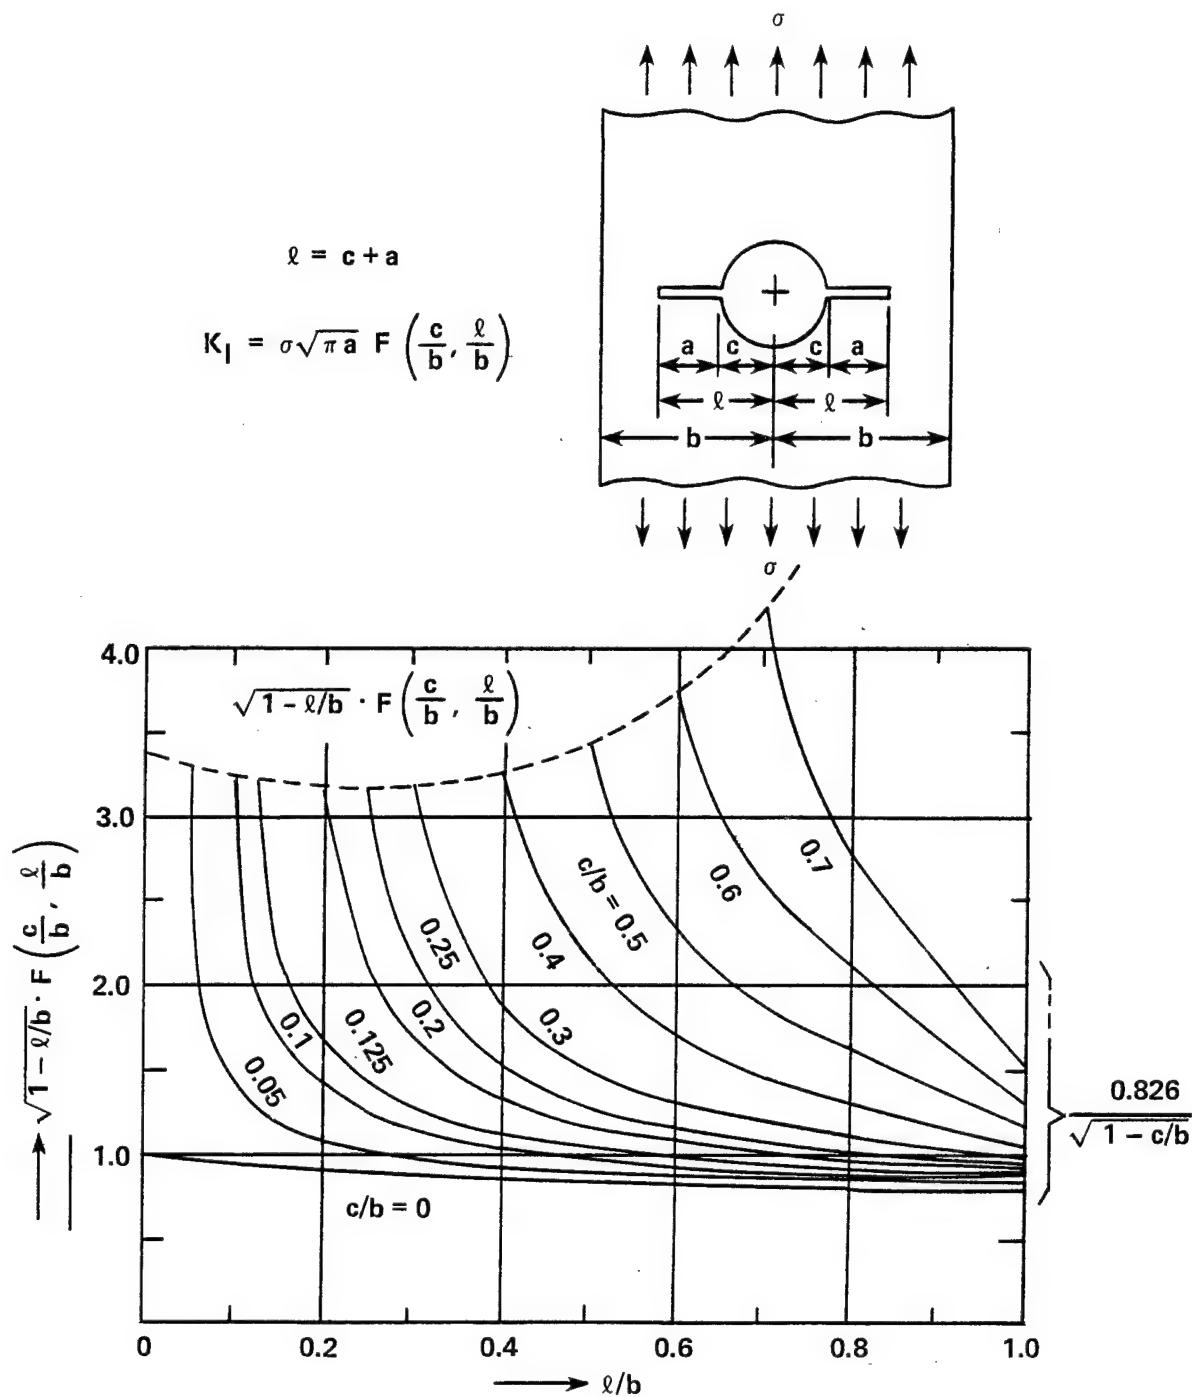
Figure 7. Stress Intensity Solution for Electron Beam Weld Specimens (reference (c))

It was then necessary to provide a conversion from the geometry of the test specimen to that of a weld intersect hole in the wing carrythrough section. This was accomplished by correlating stress intensity factors (K_I). A stress intensity factor solution by Newman and Tada (reference (c)) was employed for the test specimen. This solution is designed for a finite width panel with a symmetrically cracked center hole under uniform tension and is illustrated in Figure 7. In the figure, the curve for $c/b = .125$, the hole radius to panel half-width ratio for the specimen, was constructed by interpolation.

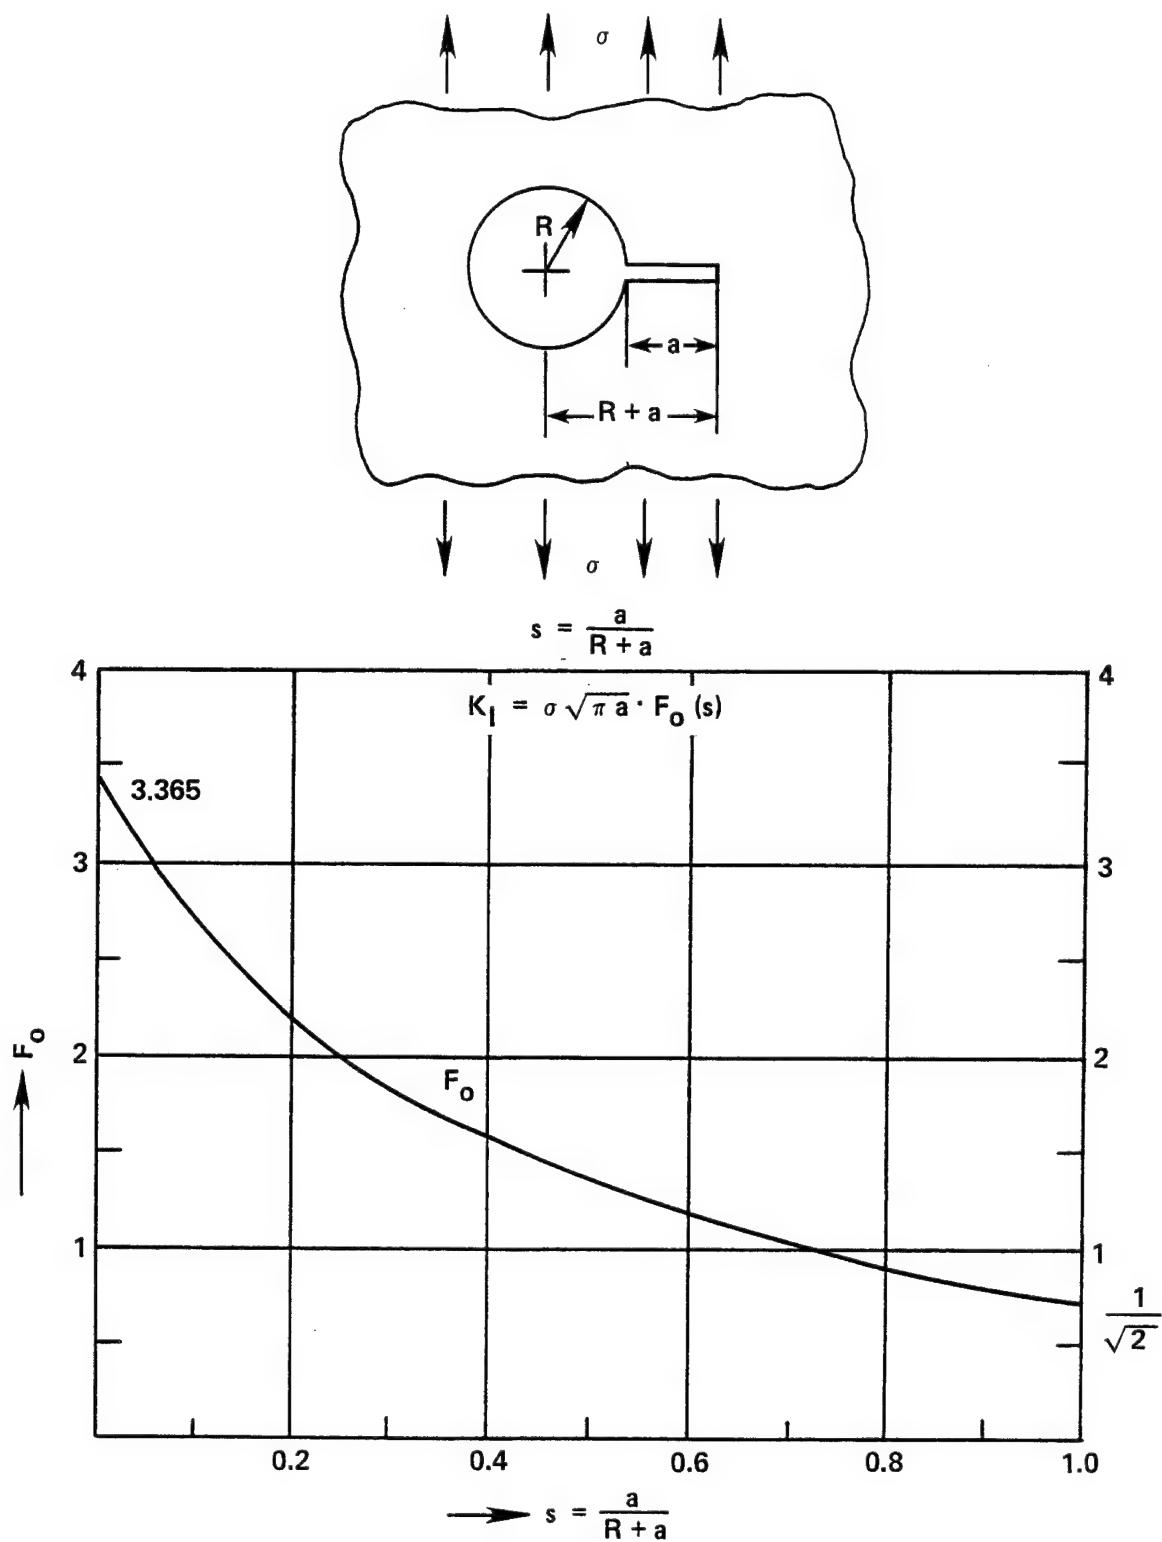
Figure 8. Stress Intensity Solution for Weld Intersect Hole with "Spike" Defect (reference (d))

The Bowie solution for a singly cracked hole (reference (d)), specified for uniaxial stress, was employed to simulate a hole in a weld intersection with an incompletely removed "spike" defect. This solution is illustrated in Figure 8. "Normalized" stress intensity factors were calculated for a specimen geometry over a range of total crack lengths ($2 l$) and for 1/4 inch (6.35 mm), 1/2 inch (12.7 mm) and 1 inch (25.4 mm) diameter weld intersection holes over a range of single crack lengths (a). For convenience unity was used for the stress term (σ) in all calculations, and all dimensions including crack lengths were in millimeters. Thus, the numerical results obtained for stress intensity factors (K_I) were comparable to each other, but had no relationship to actual stress intensity factors encountered by the specimens or the airplanes. Results of these calculations are plotted in Figures 9 and 10.

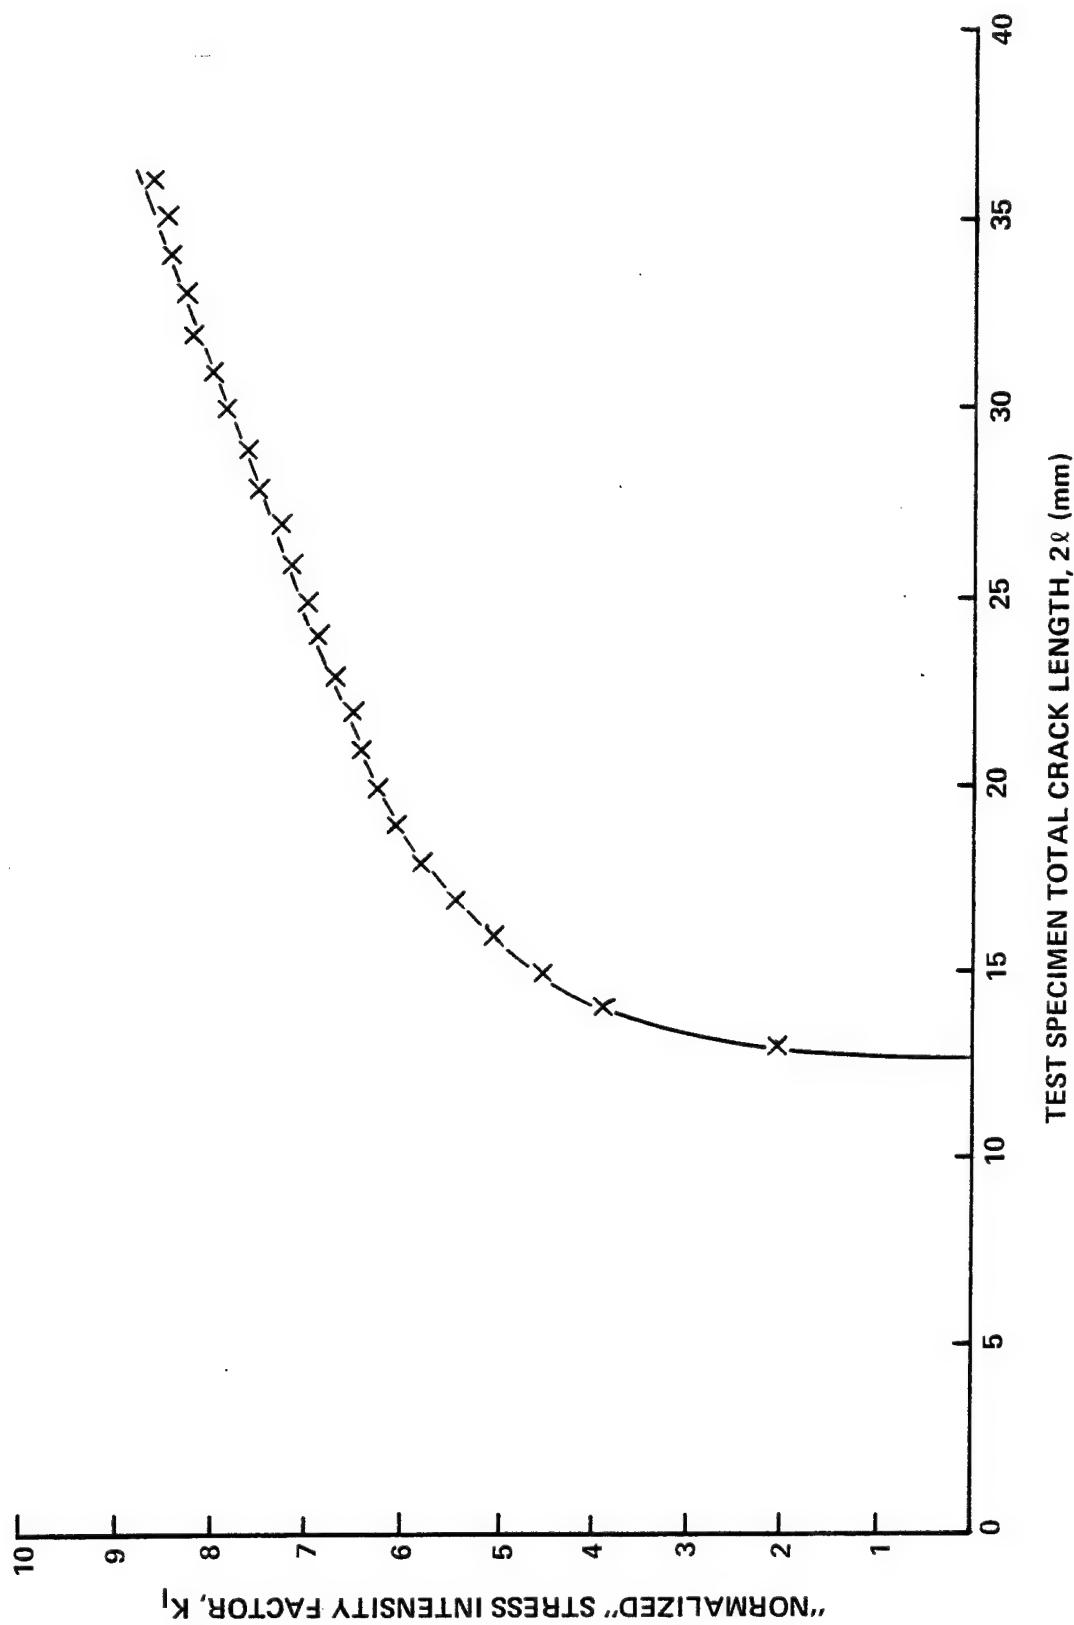
Figure 9. Stress Intensity vs. Crack Length Relationship for Electron Beam Weld Test Specimens

From Figures 9 and 10 it was then possible to find for any value of the specimen total crack length ($2 l$) the corresponding weld intersect hole defect size (a) that would result in the same stress intensity level (K_I) for the same applied stress (σ). This correlation, plotted in Figure 11, was used in conjunction with the data bounds on Figures 5 and 6 to determine range of life expectancies for various sizes of defects associated with the three hole sizes mentioned above.
